**Continental Business Center (aka Bridgeport Industrial Park) Fire
CERCLA Emergency Response
Bridgeport, Montgomery County, PA**

**RECORD OF USEPA ACTIVITIES
"OSC RECORD"**

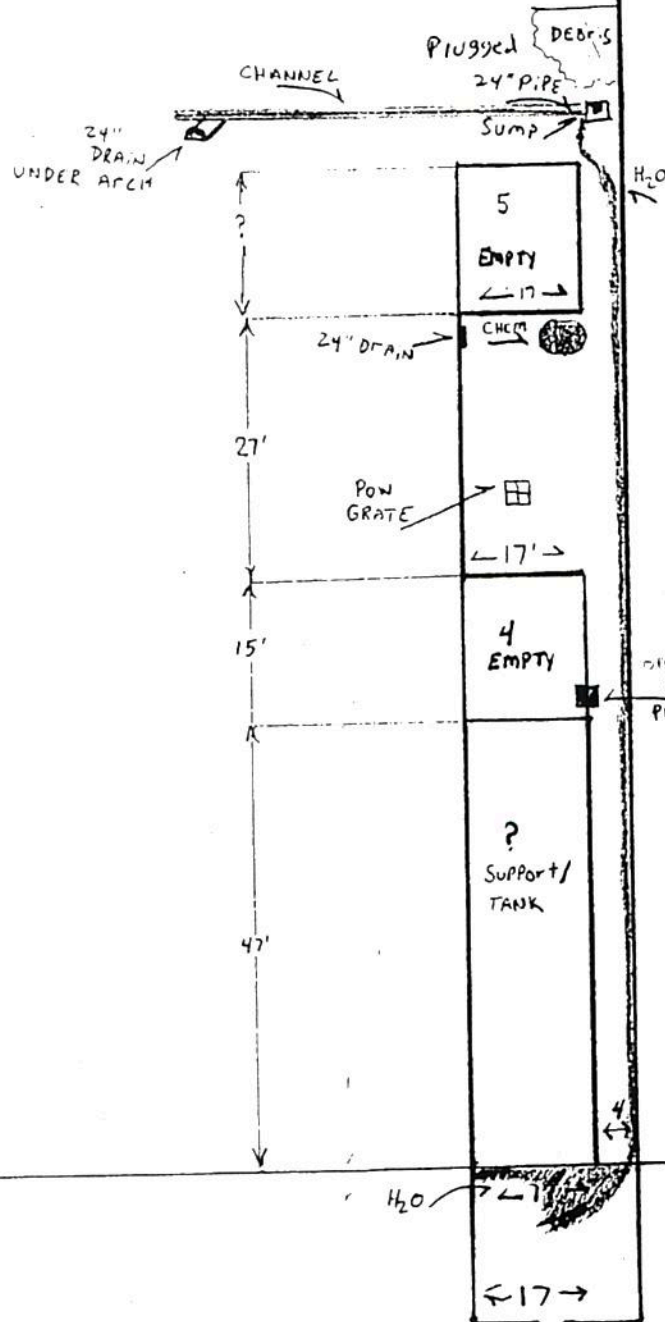
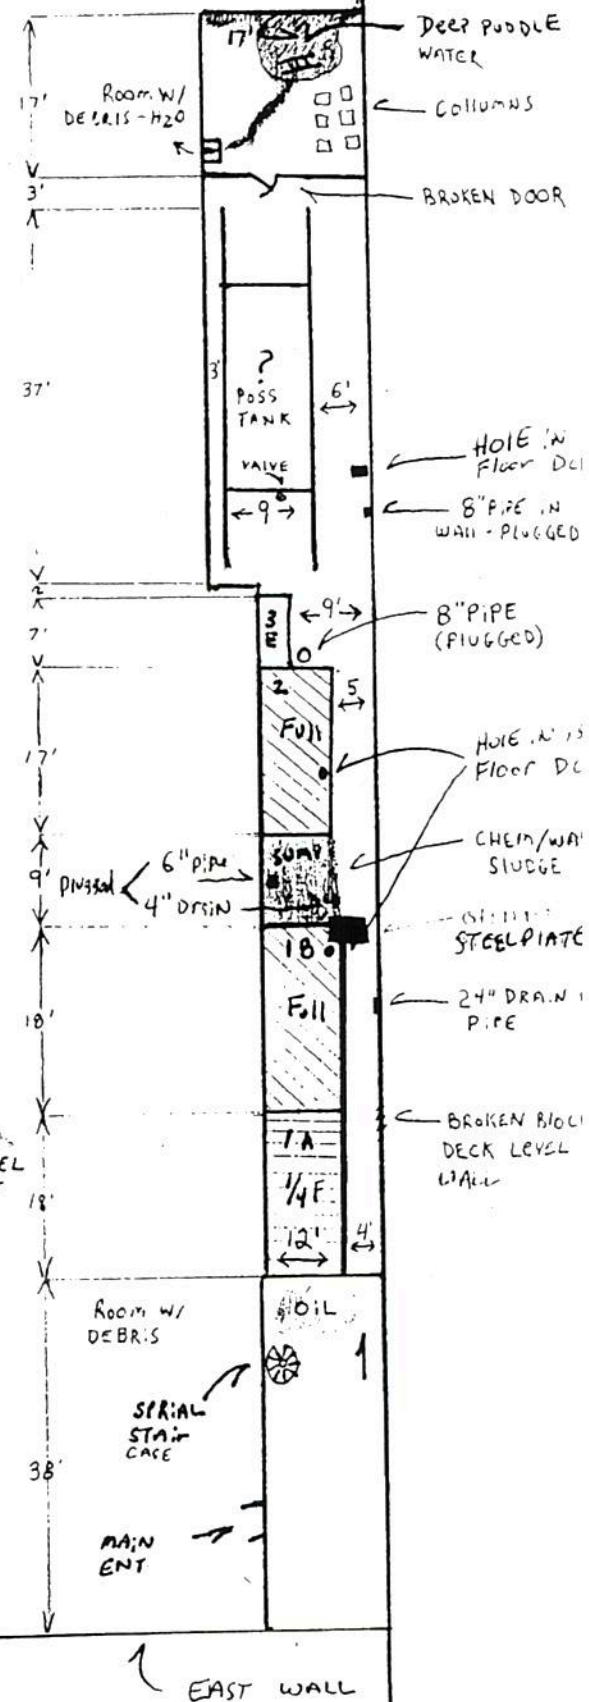
BASEMENT WAREHOUSE

north wall and floor, and several sumps/pits with unknown exit points. The USCG-AST prepared a sketch map of the basement corridor based upon several entries. The sketch map will be updated as additional information regarding drains and plugs is generated. The floor contains a large amount of chemical that has dropped through from the first floor (solid and liquid). Liquid exists in at least 3 tanks. The condition of the tanks and valves is unknown, but liquid is currently being held within (although tanks are weeping through cracks). The condition of the area behind the south wall is unknown; an old print indicates that area contained "fibre tanks" and the owner has indicated that much of it was "backfilled" when the warehouse area was improved. The western edge of the basement area under the warehouse is accessible and it contains tanks, piping, gutter drains, sumps, and machinery. EPA will continue effort to determine if liquid in the footprint of the chemical warehouse can be contained/isolated from the canal and River.

EPA has been able to identify and plug at least two possible drainageways in the MCC Warehousing basement area, but additional drains found 29 and 30 May are not yet addressed as they exist in sump areas that contain sludge material. USCG-AST entries have resulted in a sketch map that identifies known and potential drains from the basement area. The owner informs and OSC has observed that much of the basement area south of the mapped area and the majority of the warehouse footprint was backfilled in the past. It is unknown if drains were removed or plugged or if chemical has dropped into these areas (the OSC has observed chemical entering the backfilled basement area at two locations thus far, most of the area is still covered by burned rubble and chemicals). The floor of the intact basement area contains trench gutters designed to convey liquids to sump areas with unknown exit locations.

* THIS MAP PREPARED BY USCG-AST
AFTER SEVERAL ENTRIES INTO BASEMENT
AREA MAP DEFECTS AN EAST-WEST
TRENDING CORRIDOR (SEE GRID #14
ON CONTINENTAL D. AMONG PLOT)

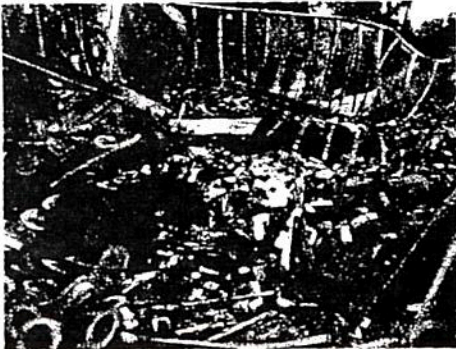
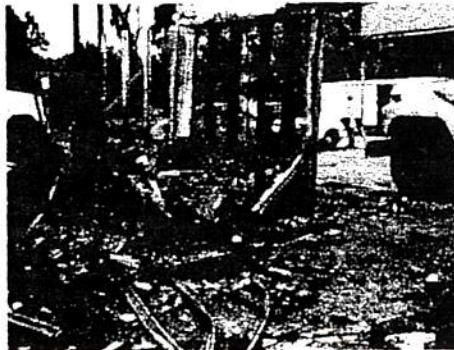
1. Bldg. C101, Georges Auto Supply

Paints, oil filters, aerosol cans, car wax and soap in trailers

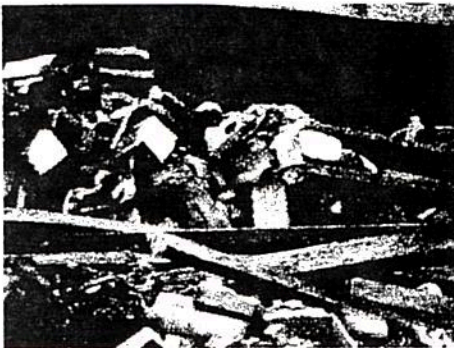
Antifreezes

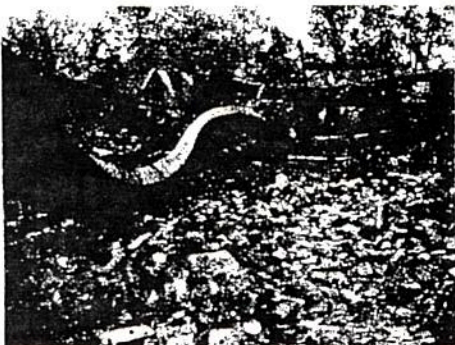
Oil filters and freon containers

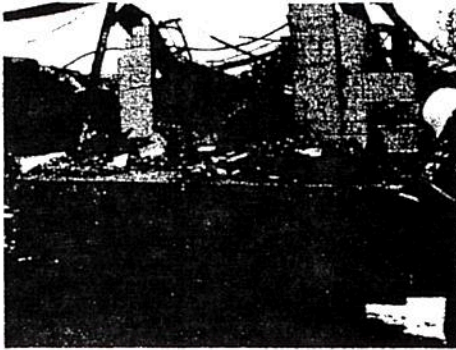
2. Bldg. C-127 MCC, Inc.

Corrosive staining

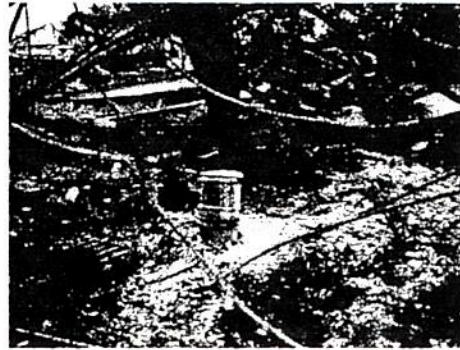
55 Gallon drum and unknown white powder

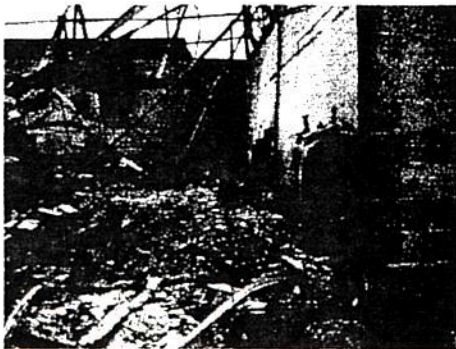
3. Bldg. C-147 Mainline Lawn Service

Heating oil tank and 55 gallon drums

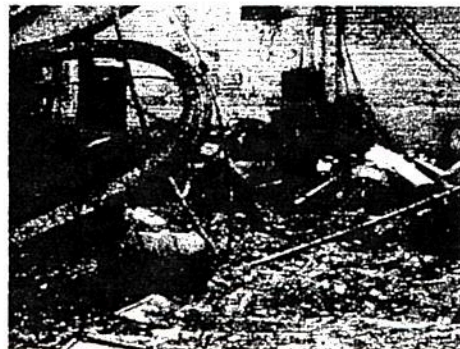
55 gallon drums and lawn equipment

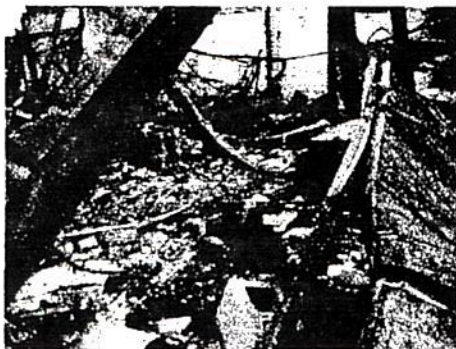
4. Bldg. C-177 Restoration Station

Aerosol paint and 55 gallon drums

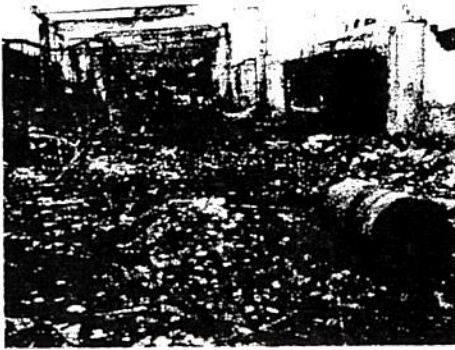
5. Bldg. C-185 Valley Forge Candle Co.

Candle wax, candle molds, 55-gallon drums and 5 gallon containers

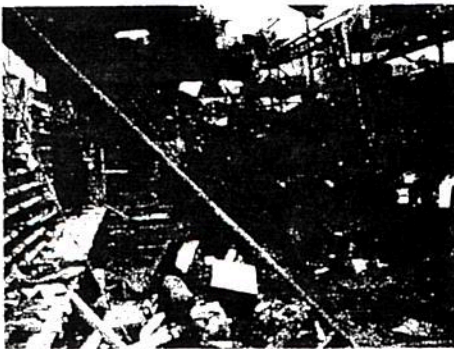
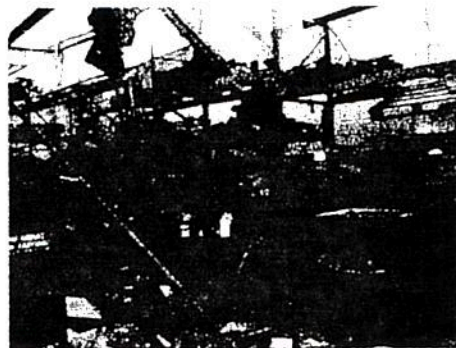
6. Bldg. C-193 ARB Breadcrumbs

Repair shop containing oils, antifreeze and general shop waste

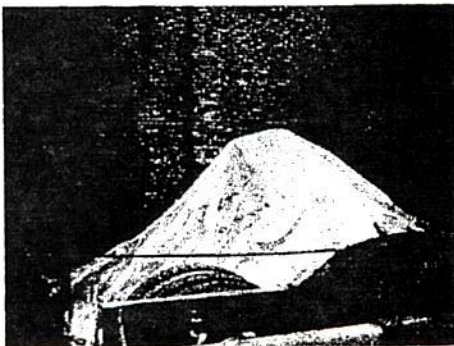
7. Bldg. J-130 Centex Environment

PCB Contaminant pile

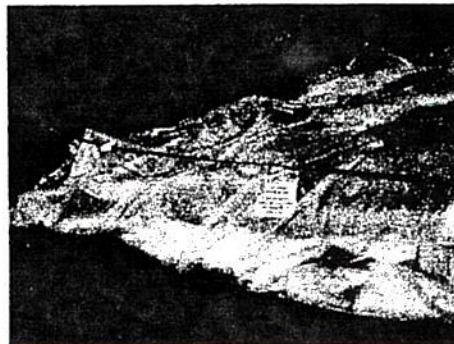
Asbestos Pile

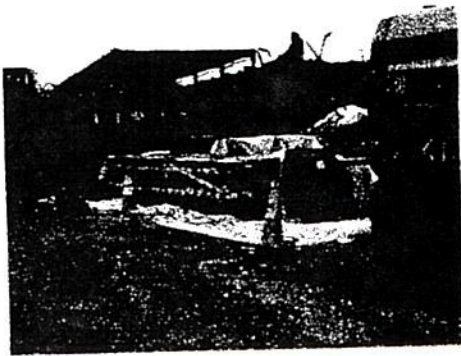
8. MCC Loading Dock

Contractor Waste, paint cans

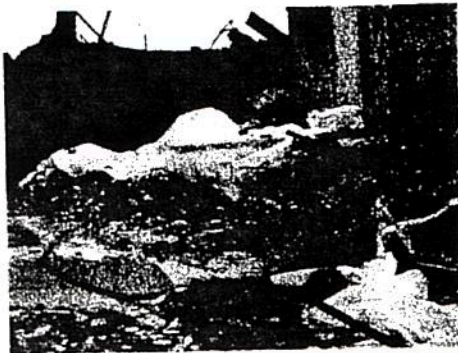
9. MCC Warehouse

Sulphate

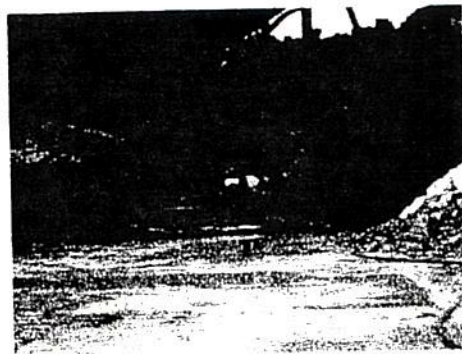
Lead Chromate in background. Residual Titanium Dioxide on floor.

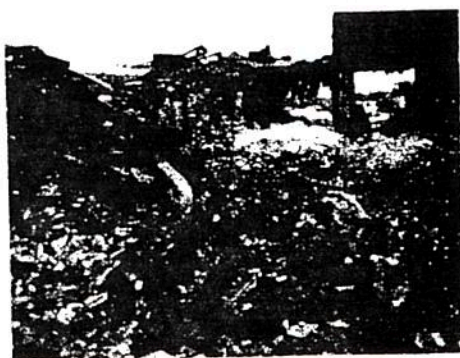
10. Bldg. M-17 Auto warehouse supply

Oil jugs, aerosols, oil filters, and lead chromate (Bldg. M-135)

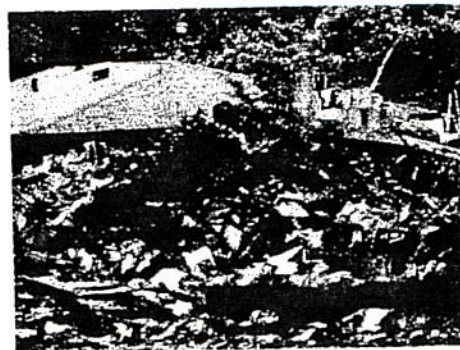
Aerosols

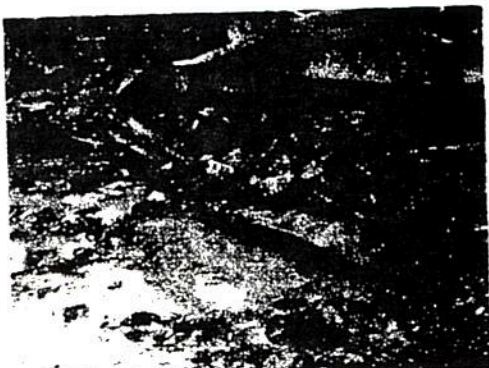
Antifreeze and aerosols

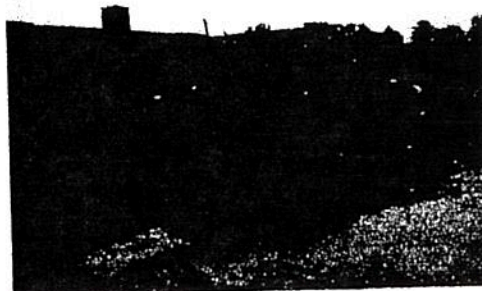
Freon and aerosols

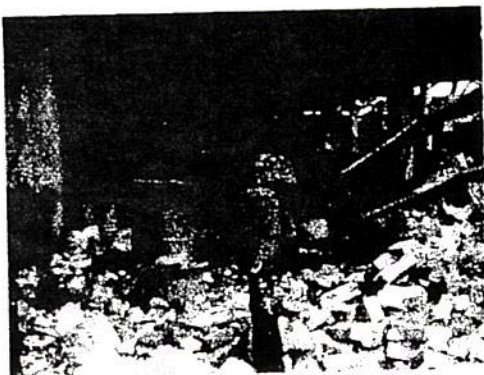
11. MCC Warehouse

55 gallon drums, puddle of copper,
and venting drum

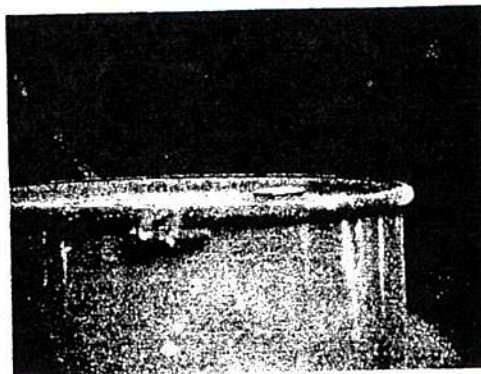
Venting drum
